# Collision with terrain involving Aeroprakt A22 LS, 24-7390

Mt Jack Station, New South Wales, 1 November 2017

Technical analysis of control cables  
AE-2018-018

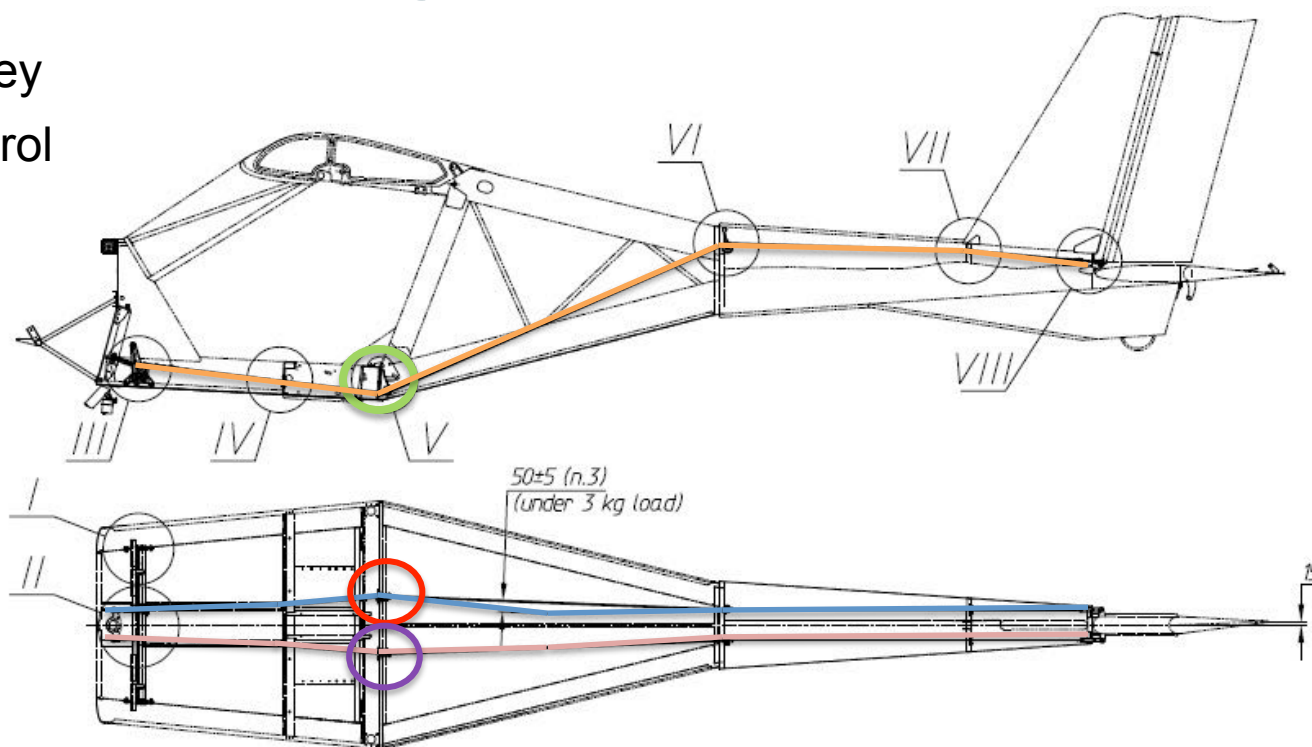
Figure 1

Image: Aeroprakt,  
annotations ATSB

Fractured Cable
-

Damaged Cable

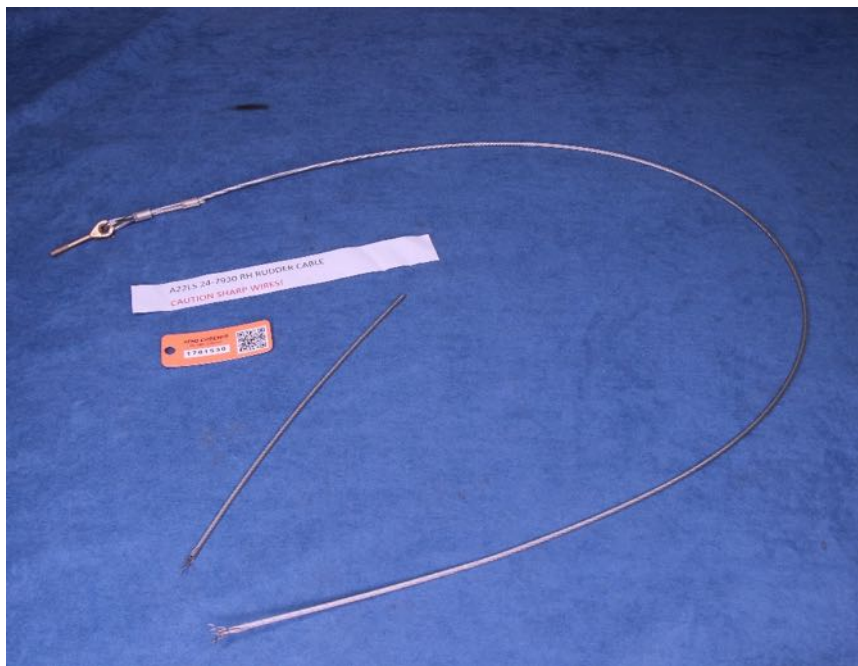
*Figure 2*

RH Rudder Control Cable

Following the accident, the right hand rudder control cable (Figure 2) was found completely fractured. The cable was cut for transport beyond the point of fracture and was provided to the ATSB for analysis.

- It was determined that the fracture occurred the approximate position of the forward pulley (see Figure 1).
- Microscopic examination revealed that approximately 65% of the wires in the cable had fractured in fatigue, with the remainder failing in overstress.
- Based on the amount of fatigue it is likely that the cable would have been unserviceable at the last 200-hourly inspection, as per the Aeroprakt maintenance manual section 12.7 (see next slide).

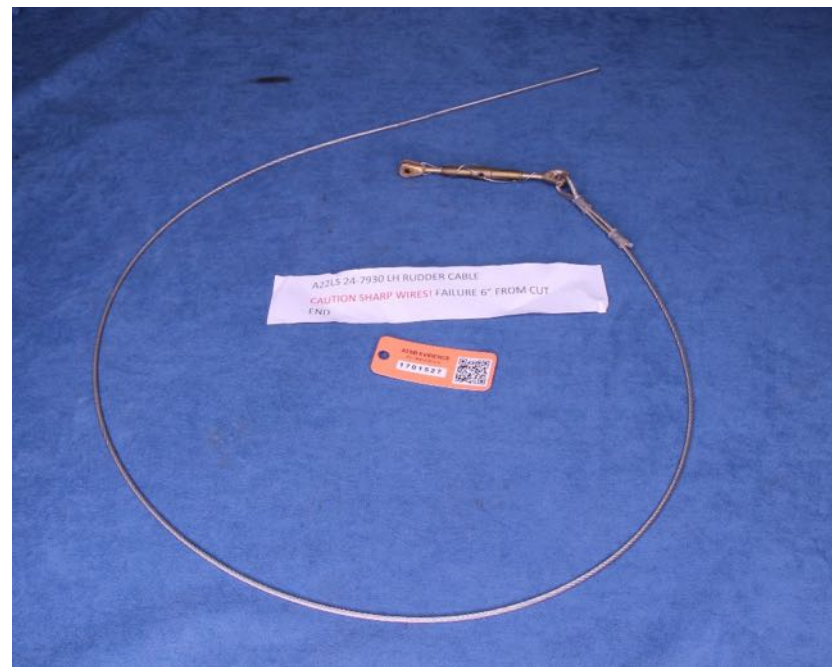
*Figure 3*

LH Rudder Control Cable

The left hand rudder cable had not completely fractured at the time of the accident. Figure 3 shows the cable section provided to the ATSB, which was also cut for transport.

- Local deformation of the wires (see Figures 9 and 10) was observed at the approximate position of the forward pulley, the same area where the RH cable had fractured.
- Running a hand along the wire revealed a number of sharp and deformed areas, indicating fractured or deformed wires within the cable.
- Microscopic examination of these areas revealed a number of wires with fatigue fractures as shown in Figure 9 and 10. As with the RH cable, under the requirements set out in the maintenance manual this cable was unserviceable, and likely would have been unserviceable at the last inspection.

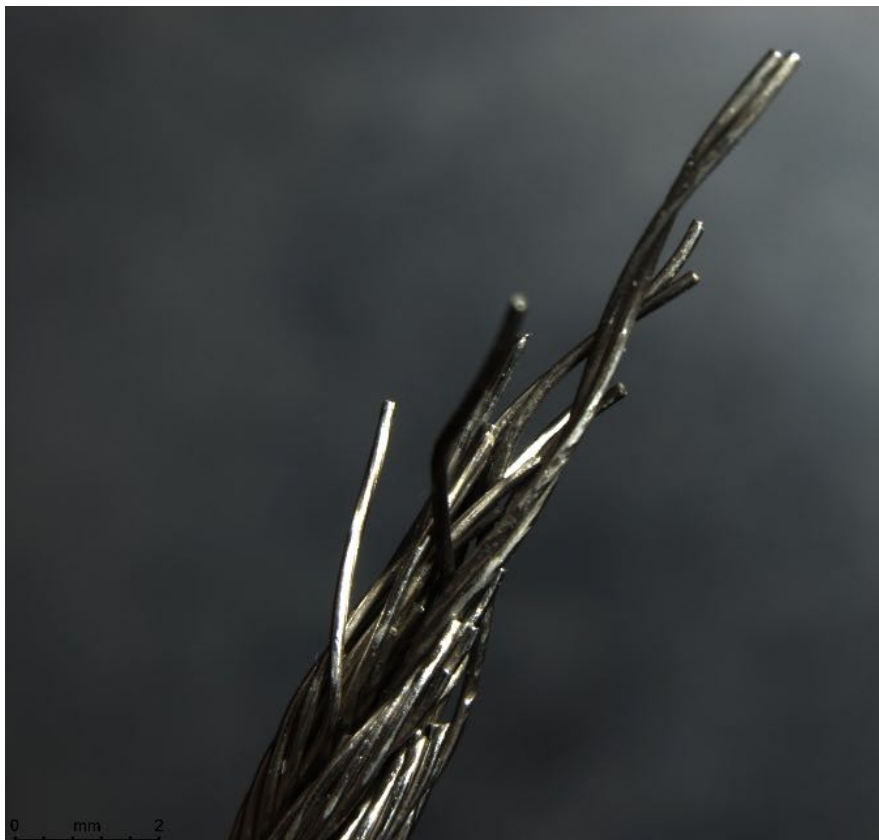
*Figure 4*

Figure 4 shows an image of the fractured end of the cable taken during the microscopic examination. Figures 6 and 7 show examples of wires that have fractured in fatigue and overstress.

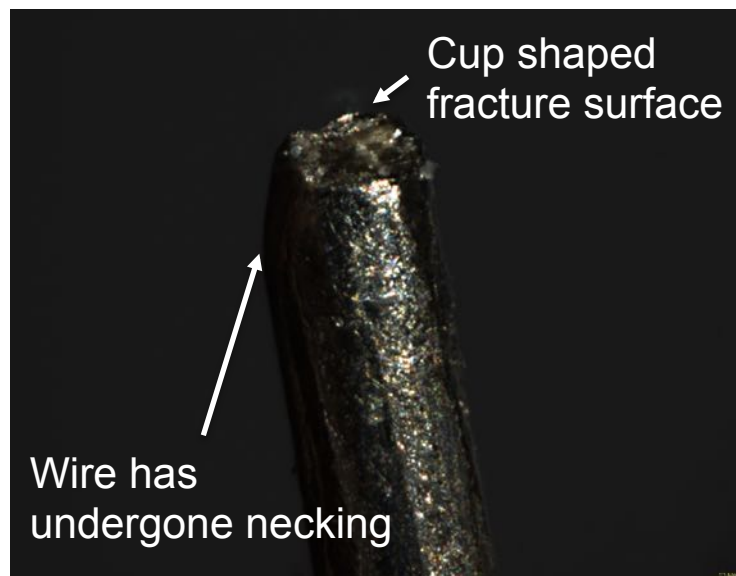
Figure 6

Overstress

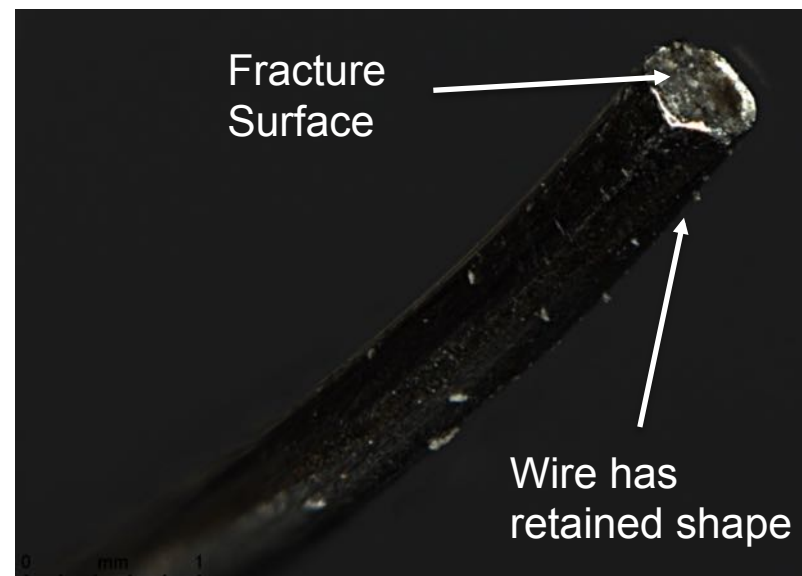
Figure 7

Fatigue

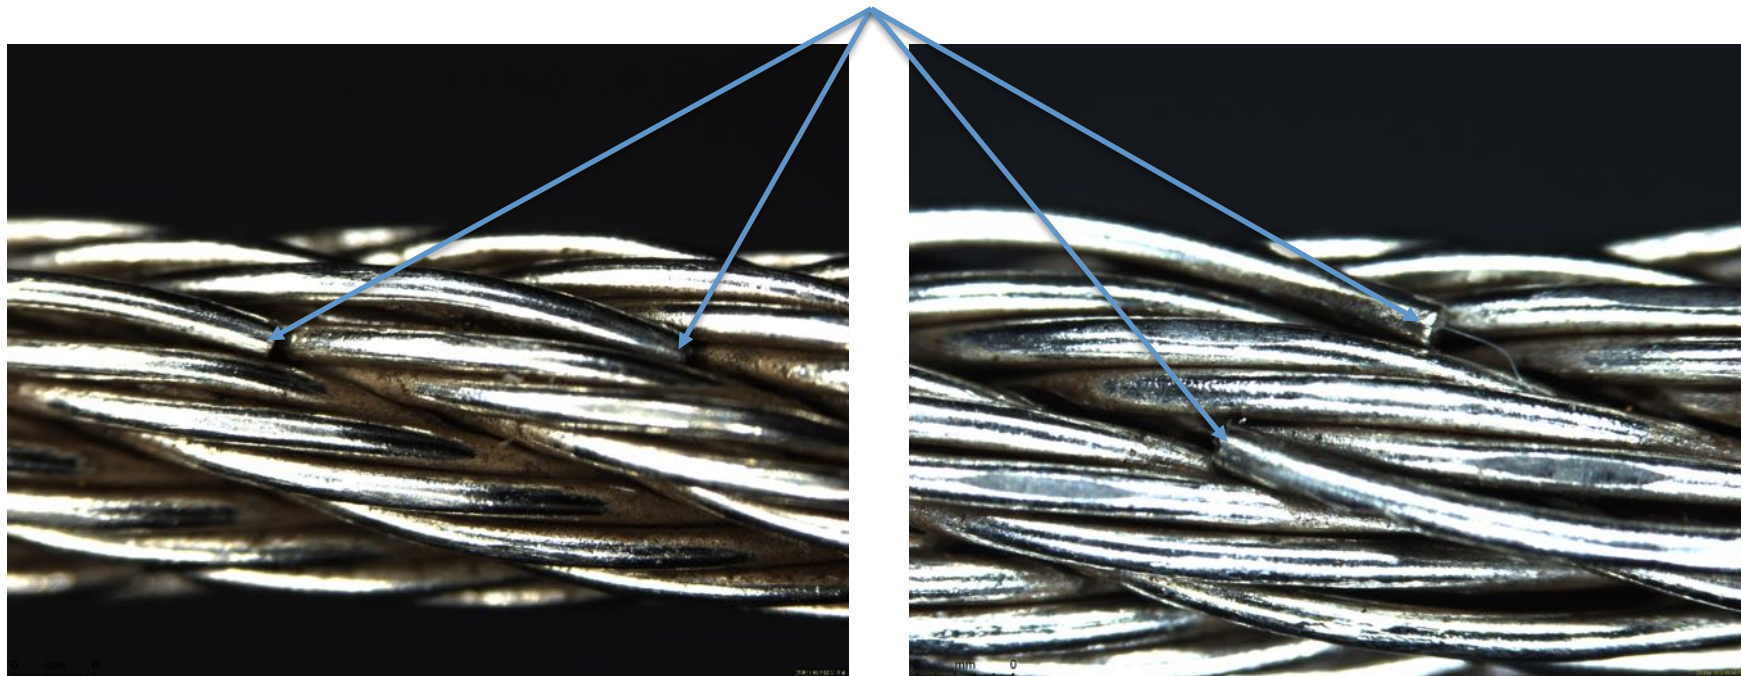
*Figure 8*

Fatigue fractured wires

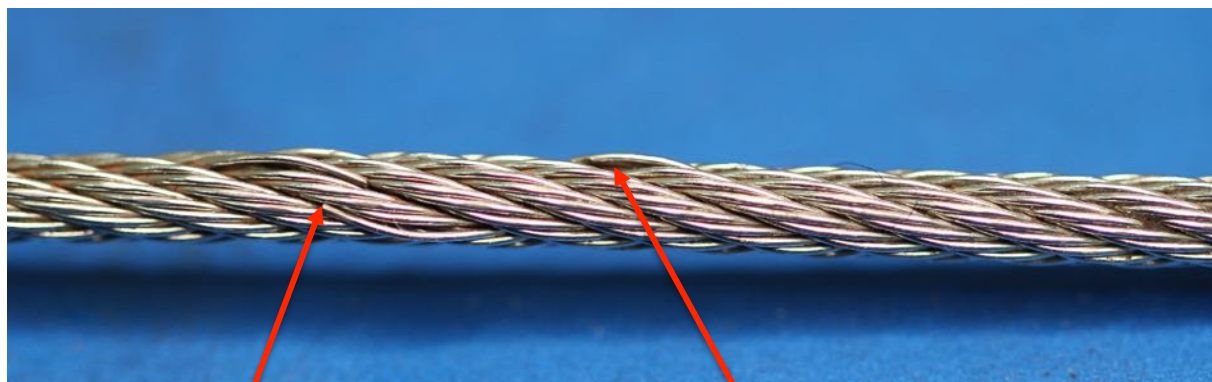
*Figure 9*

Fractured Wire

Local Deformation

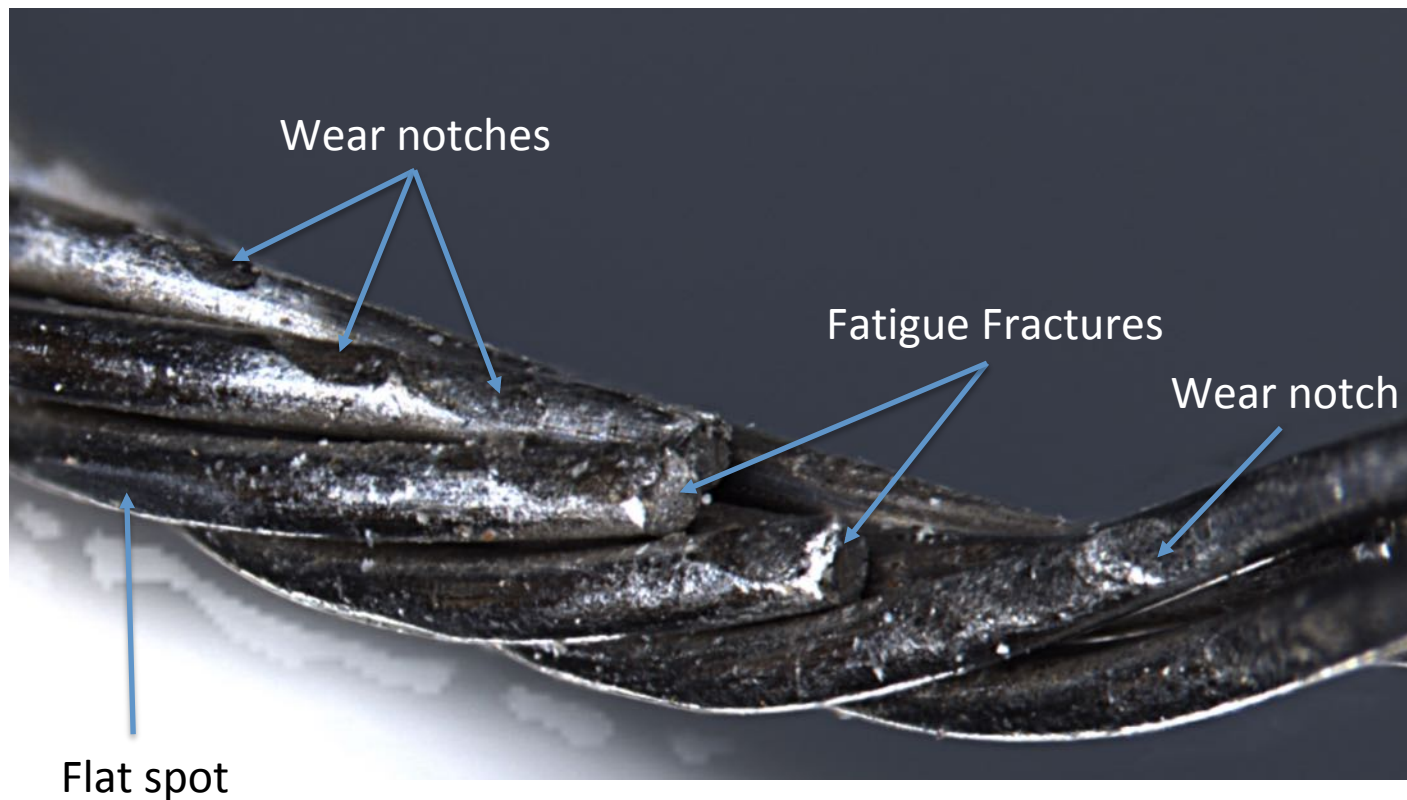
*Figure 11*

Wear was observed on both cables which may have contributed to the fatigue fractures observed. These can be seen in Figure 11 and are described below.

- Figure 11 shows noticeable wear notches caused by relative motion of wires across each other. This wear can be a contributing factor to fatigue fractures by reducing the diameter of the wire and creating a stress concentration.
- Flat spotting on the wire has been caused by the repeated motion the cable over a pulley (Figures 11 and 12). This type of wear over time can lead to fatigue and fracture of the wire rope.

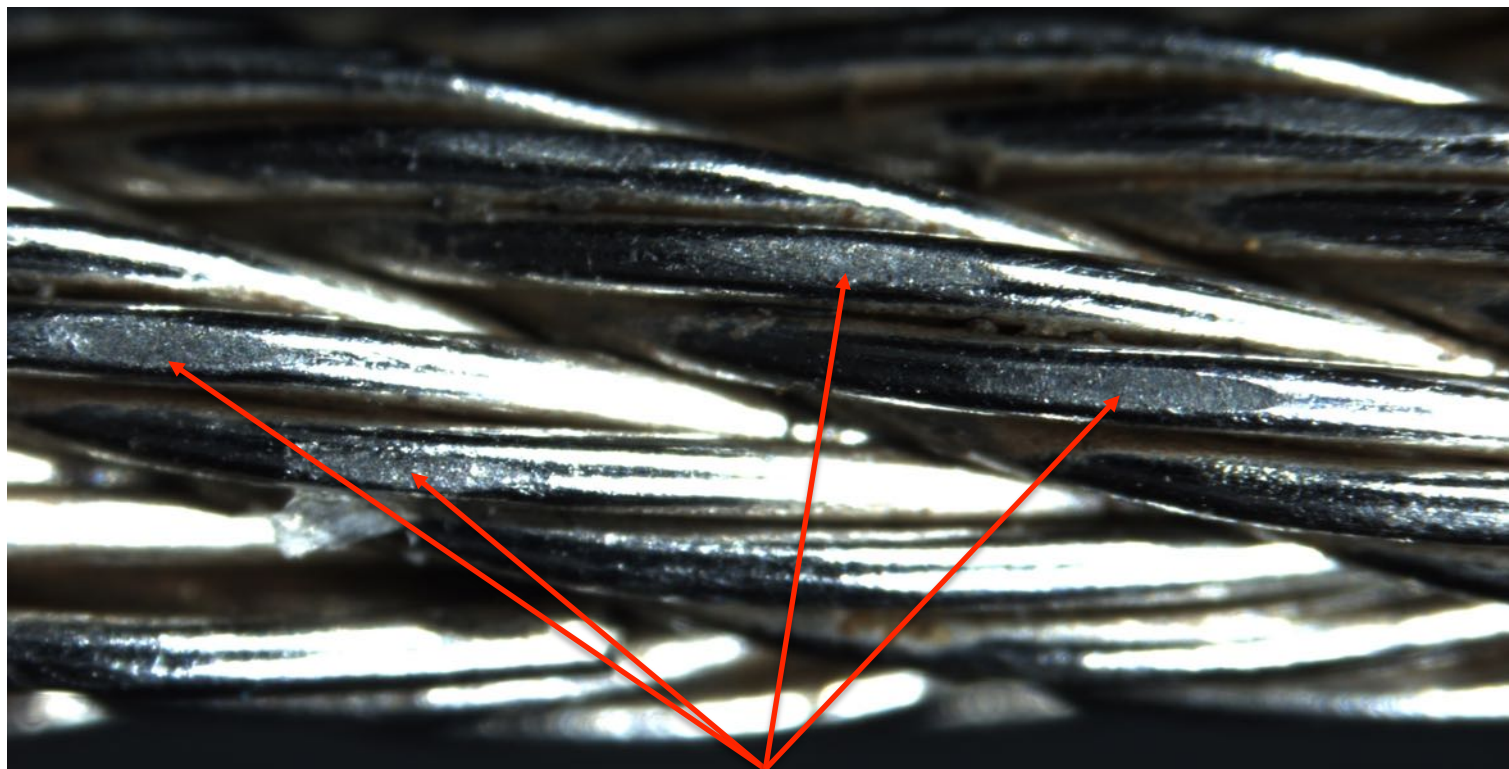
*Figure 12*

Flat spots

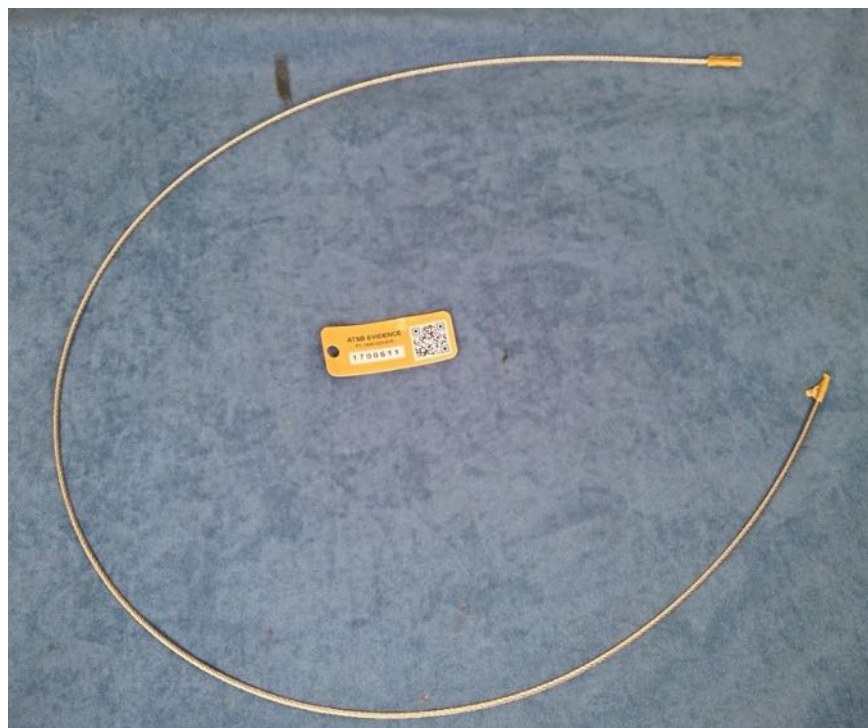
For comparative analysis, RAAus provided the ATSB with an exemplar cable obtained directly from the Aeroprakt Factory in Ukraine (see Figure 13). Visual and microscopic examination did not reveal any concerns with the cable such as wear, corrosion or existing damage.

*Figure 13:  
Factory Cable Sample*

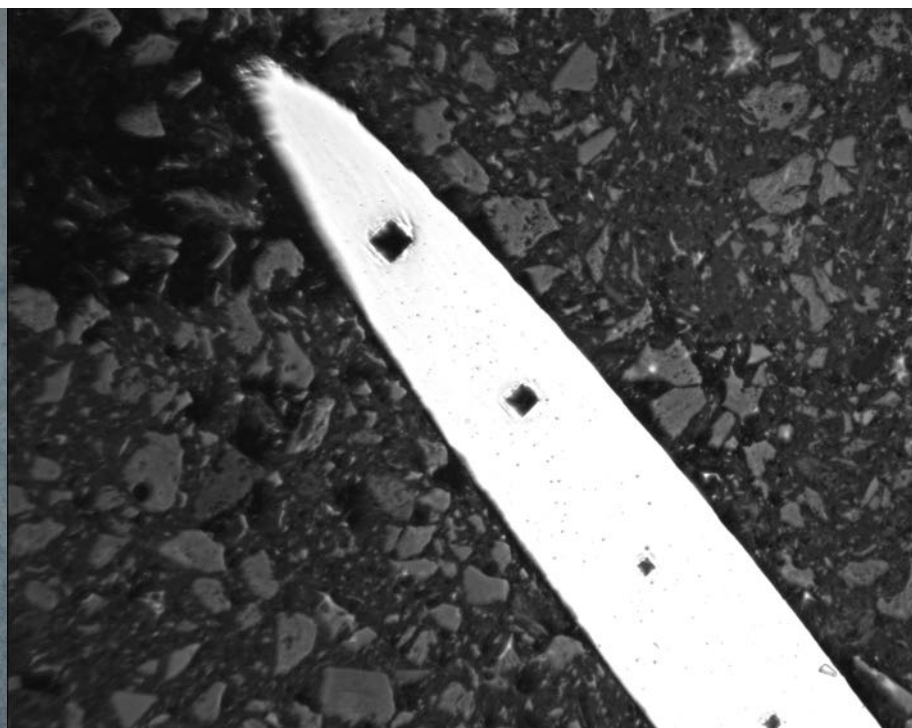
A series of hardness tests were performed to obtain the approximate strength of each cable. These hardness tests (see Figure 14) did not reveal any significant deviation from the manufacturers stated properties. Most of the results were within 10% of the stated 1770 MPa strength for the cable type provided by the manufacturer.

*Figure 14:  
Sample Undergoing Hardness Test*

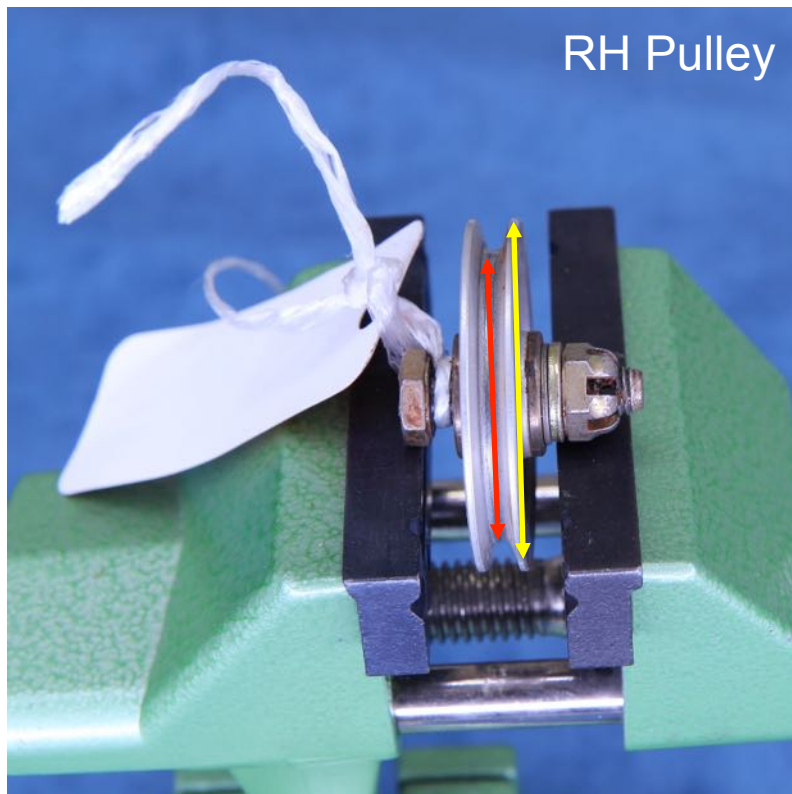
Figure 15

Due to the location of the damage to both cables, both forward pulleys (see Figure 1) were examined. This revealed some wear on both pulleys (see Figures 15 - 18), but nothing of particular concern.

The pulleys were measured to ensure that they met with the specifications outlined in the manufacturer's drawings. All dimensions were within specification; however, the diameter of the pulleys in the design was below what is recommended for aircraft cables. The absolute minimum recommended for the ratio of the diameter of the pulley to the diameter of the cable is 30:1. Based on the 2.5mm diameter cable and 37mm diameter pulley the ratio in this case is approximately 15:1, which could lead to an increase in wear and a reduction in serviceable life of the cable.

RH Pulley

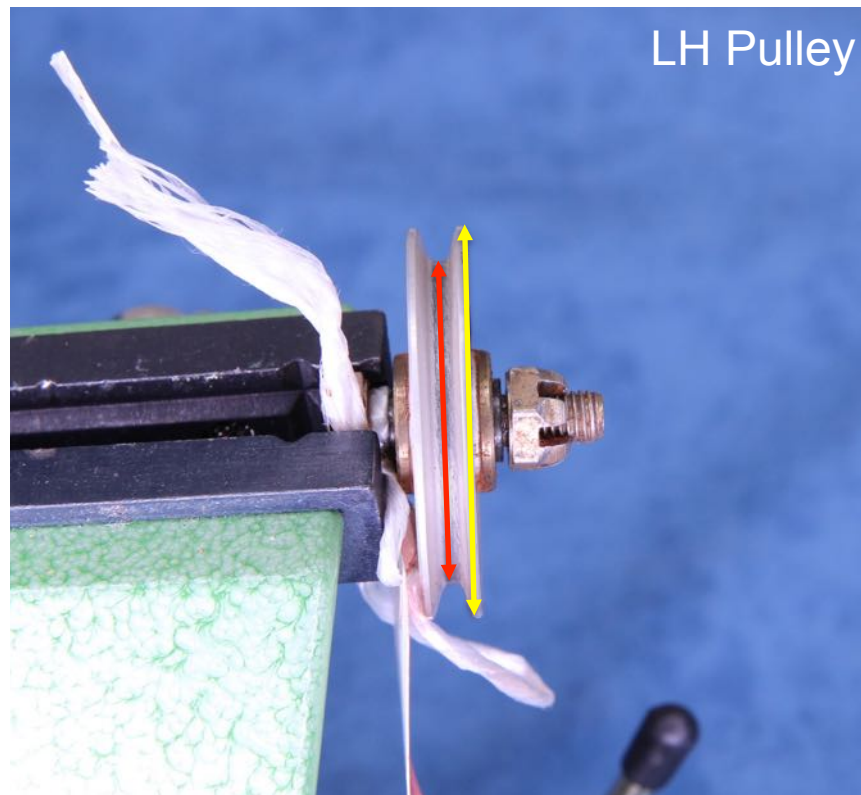
Figure 16

LH Pulley

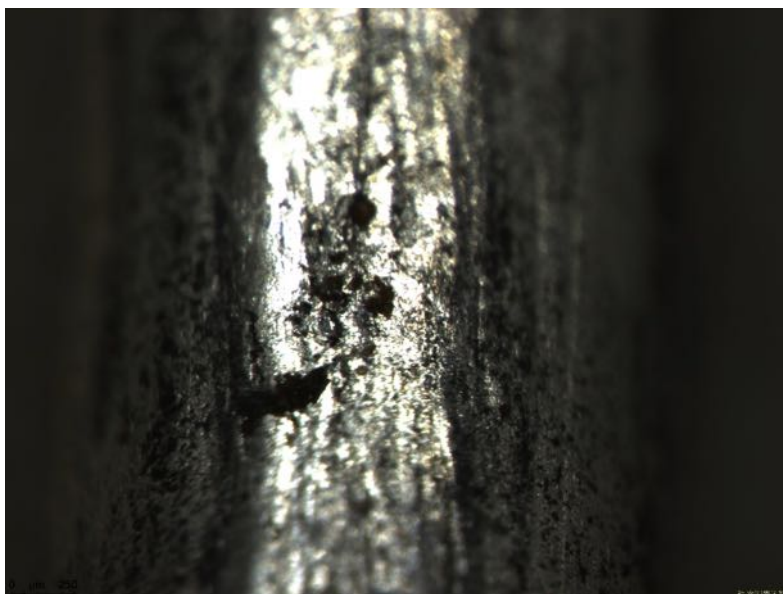
*Figure 17*

Wear on RH pulley due to cable action

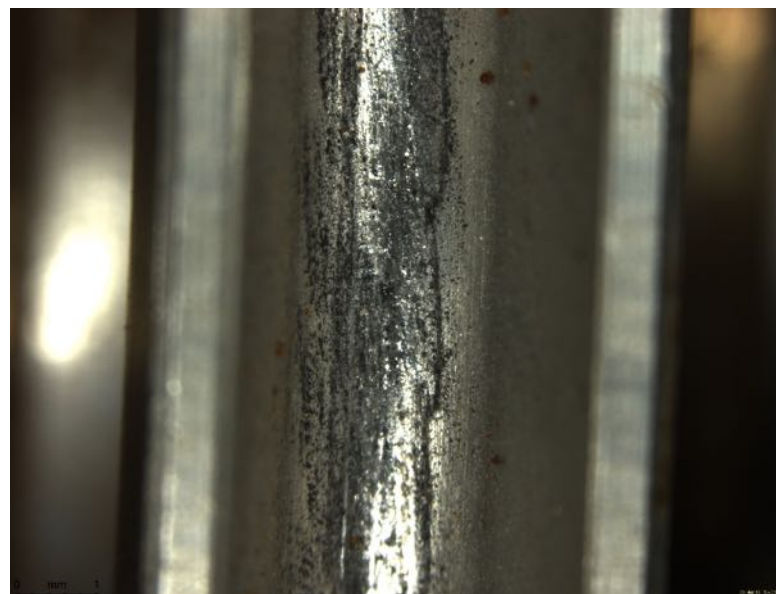
*Figure 18*

Wear on the LH pulley due to cable action
